**Flood Control Project Maintenance  
Levee Inspections**

**Fall 2011 Levee Maintenance Deficiency Summary Report**

**Reclamation District No. 0001 Union Island**

**Levee Inspection Report By Mile - Fall 2011**

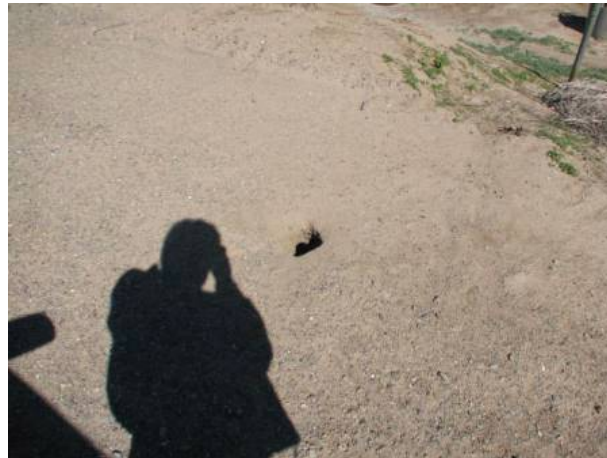
Levee Mile Report Line	3
Start Levee Mile	0.02
End Levee Mile	0.02
Location	Land Side
Category	Earthen Levee
Item	Animal Control

04/26/2011 Animal burrow in levee crown.

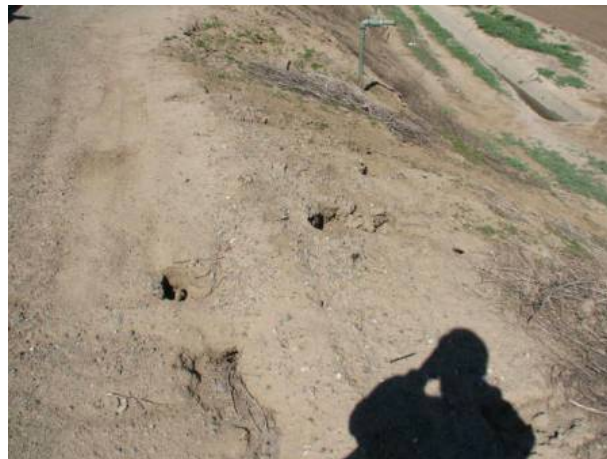
Levee Mile Report Line	3
Start Levee Mile	0.02
End Levee Mile	0.02
Location	Land Side
Category	Earthen Levee
Item	Animal Control

04/26/2011 Several burrows present in levee crown and landside slope.

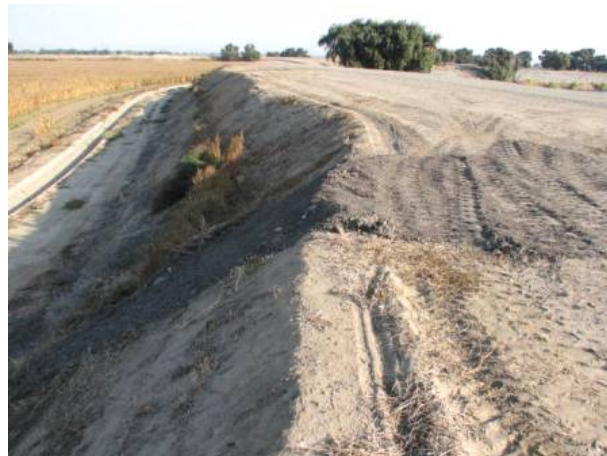
Levee Mile Report Line	4
Start Levee Mile	0.02
End Levee Mile	0.02
Location	Land Side
Category	Earthen Levee
Item	Erosion / Bank Caving

10/25/2011 Erosion site has been repaired.

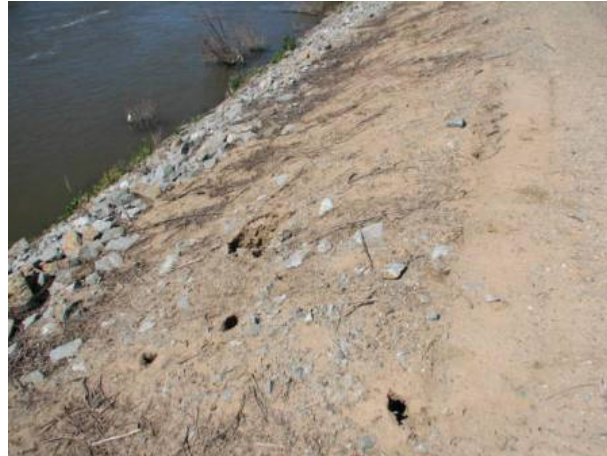
5	0.03	0.03	Earthen Levee	Animal Control	WS	M	No rodents visible, but rodent burrows visible; need to backfill and compact or grout burrows. Inspector Comments: Burrow evident on water side, burrow appears to have collapsed.	37.822403 ° -121.375937 °	37.822403 ° -121.375937 °	4 Y
6	0.07	0.07	Earthen Levee	Erosion / Bank Caving	LS	C	Note and monitor erosion site. Inspector Comments: Monitor site, erosion appears to be starting due to water runoff at this point	37.822268 ° -121.376762 °	37.822268 ° -121.376762 °	6
7	0.11	0.11	Earthen Levee	Erosion / Bank Caving	LS	C	Schedule repair of erosion site prior to the next inspection. Inspector Comments: Landside slope is eroded creating two large holes at the hinge point.04/26/2011 Repairs have been made to a portion of the location, but are not adequate and need further attention.	37.822051 ° -121.377320 °	37.822051 ° -121.377320 °	2
8	0.17	0.17	Earthen Levee	Erosion / Bank Caving	WS	C	Note and monitor erosion site. Inspector Comments: Monitor erosion site. Crown is approximately 40' wide at this point.	37.821461 ° -121.378110 °	37.821461 ° -121.378110 °	8

Levee Mile Report Line	5
Start Levee Mile	0.03
End Levee Mile	0.03
Location	Water Side
Category	Earthen Levee
Item	Animal Control
04/26/2011 Several burrows present on water side, burrows appear to be collapsing.	
jeto_f_20110923_091.jpg

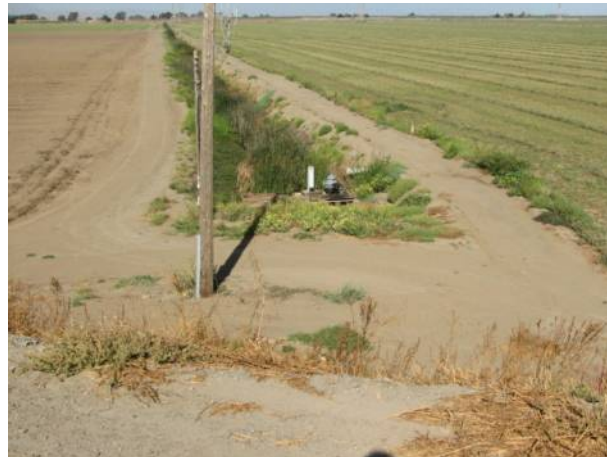
Levee Mile Report Line	11
Start Levee Mile	0.39
End Levee Mile	0.39
Location	Water Side
Category	Earthen Levee
Item	Encroachments
Drainage discharge pipe through levee freeboard.	
jeto_f_20110923_093.jpg

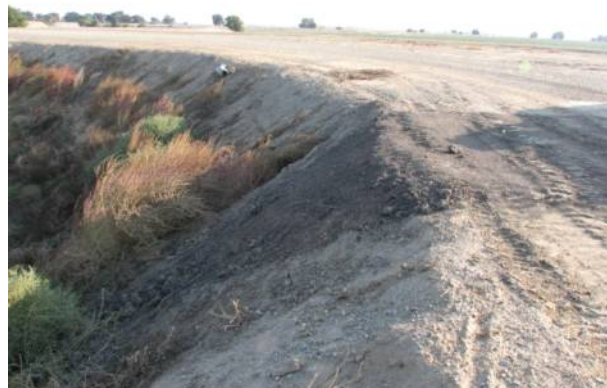
Levee Mile Report Line	14
Start Levee Mile	0.54
End Levee Mile	0.54
Location	Land Side
Category	Earthen Levee
Item	Erosion / Bank Caving
10/25/2011 Photo showing repair of erosion site.	
jeto_f_20111031_501.jpg

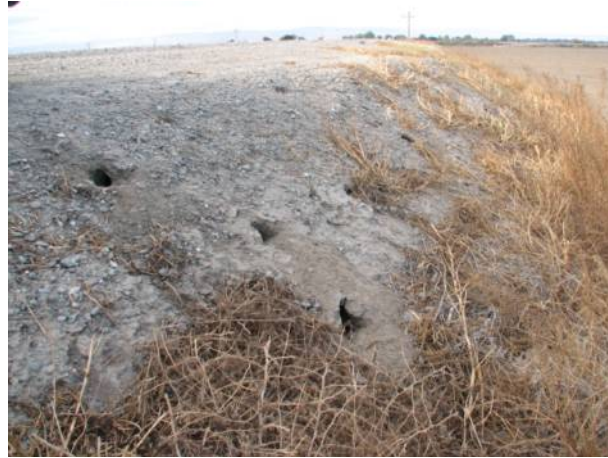
Levee Mile Report Line	17
Start Levee Mile	0.66
End Levee Mile	0.66
Location	Land Side
Category	Earthen Levee
Item	Animal Control

16	0.56	0.56	Earthen Levee	Animal Control	LS	C	No rodents visible, but rodent burrows visible; need to backfill and compact or grout burrows. Inspector Comments: Active burrows present, burrows are within erosion site.	37.817547 ° -121.380285 °	37.817547 ° -121.380285 °	26
17	0.66	0.66	Earthen Levee	Animal Control	LS	M	No rodents visible, but rodent burrows visible; need to backfill and compact or grout burrows.	37.817249 ° -121.382026 °	37.817249 ° -121.382026 °	15 Y
18	0.67	0.67	Earthen Levee	Encroachments	LS	W	Pipe Inspector Comments: Drainage discharge into Old River. No photo found from previous inspection. 04/26/2011 photo added.	37.817134 ° -121.382099 °	37.817134 ° -121.382099 °	20 Y
19	0.67	0.67	Earthen Levee	Animal Control	CR	M	No rodents visible, but rodent burrows visible; need to backfill and compact or grout burrows. Inspector Comments: Deep vertical rodent hole in crown of levee, see photo. Shovel handle stopped at bend in burrow.	37.817109 ° -121.382192 °	37.817109 ° -121.382192 °	27 Y

Active rodent holes on levee slope.

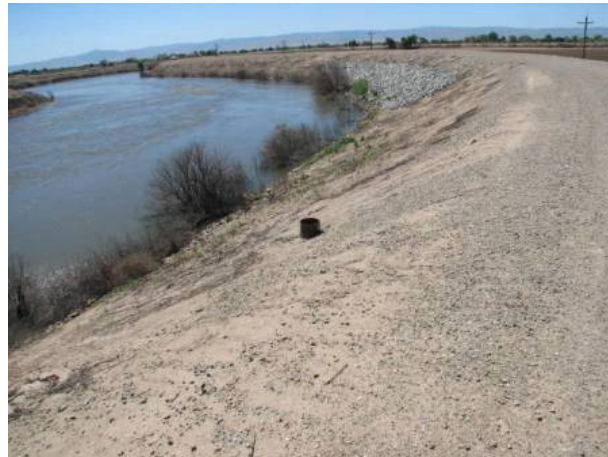
Levee Mile Report Line	18
Start Levee Mile	0.67
End Levee Mile	0.67
Location	Land Side
Category	Earthen Levee
Item	Encroachments

04/26/2011 Discharge pipe in water side slope.

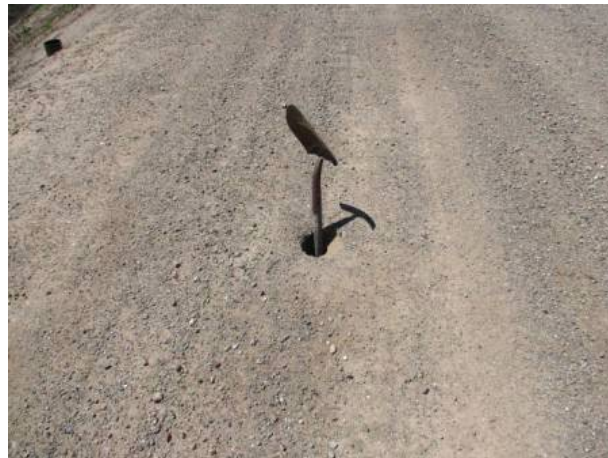
Levee Mile Report Line	19
Start Levee Mile	0.67
End Levee Mile	0.67
Location	Crown
Category	Earthen Levee
Item	Animal Control

04/26/2011 Deep vertical burrow in levee crown.
